NAVAL POSTGRADUATE SCHOOL

THESIS

**STUDY OF COMPOSITE INTERFACE STRENGTH
AND CRACK GROWTH MONITORING USING CARBON
NANOTUBES**

September 2009

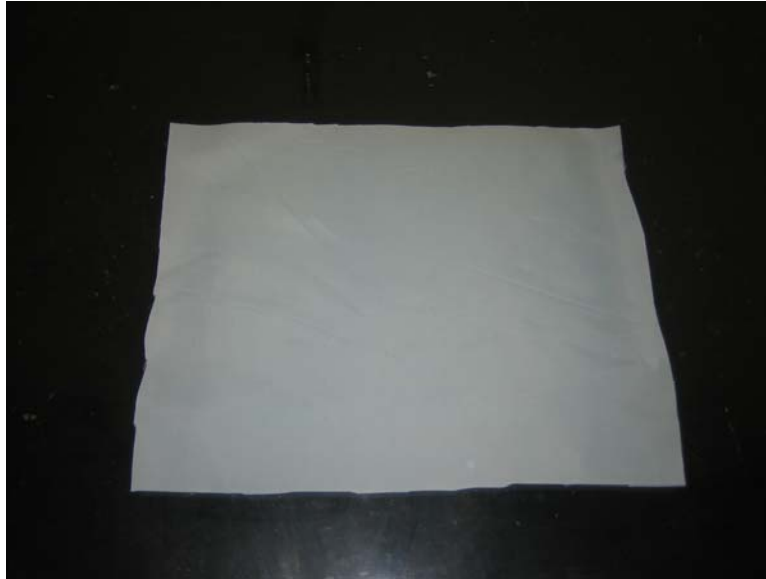
Figure 5. Peel Ply Laid on Top of Distribution Media for Co-Cured Samples

To begin making the two-step cured samples, a layer of peel ply was placed on a piece of glass to allow for easy removal of the sample upon completion of the VARTM process. The glass used must be at least 1.27 cm (0.5 in) thick, in order to be able to withstand the extreme heat generated during the resin curing process. When making a co-cured sample, a layer of distribution media is laid down first, covered by a layer of peel ply, as shown in Figures 4 and 5.

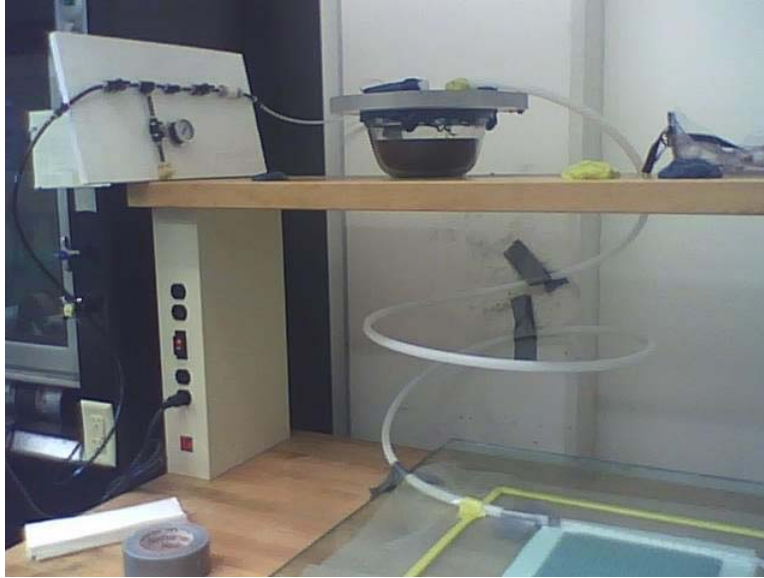
Figure 8. Gage Board and Resin Trap

In order for the resin to be pulled through the fiber material, a Rietschel Thomas Vacuum Pump model 2688CE44 was used. Tubing was hooked up to this pump and run through a gauge board to a resin trap, as shown in Figure 8. The resin trap was used to protect both the pump and gauge board from excess resin. From the resin trap, solid ½-inch diameter plastic tubing was measured and cut to be used inside the vacuum bag as the outlet for the resin. This same tubing was used to suck resin from the bottom of the

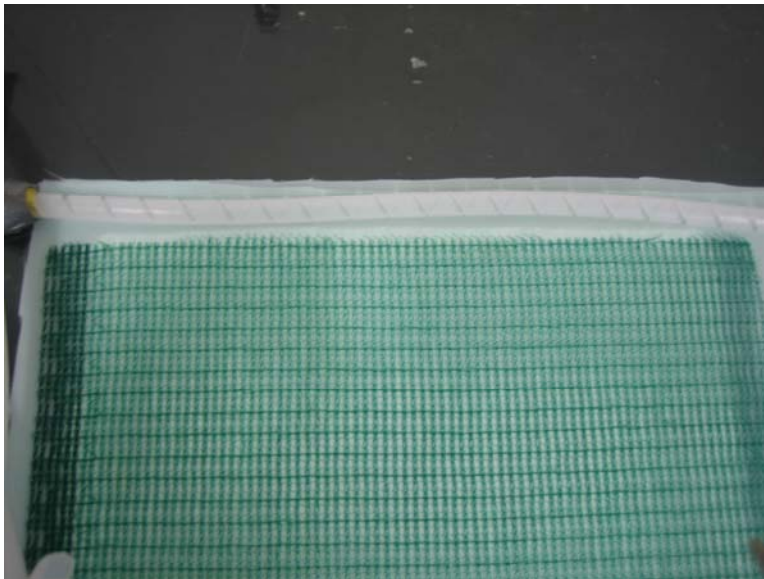
Figure 9. Spiral Tubing Used at the Top and Bottom of Sample Set-up

sample to the top. Attached to both the inlet and outlet tubes, and spread across the top and bottom of the sample, was spiral tubing, as shown in Figure 9. This tubing allowed for an even distribution of the resin throughout the sample.

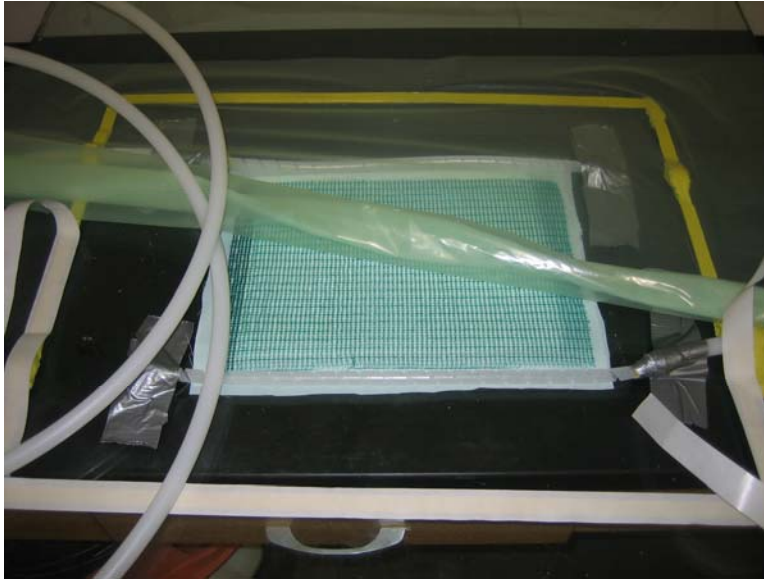
Figure 11. Rolling Out the Plastic Sheet Used to Form the Vacuum Bag

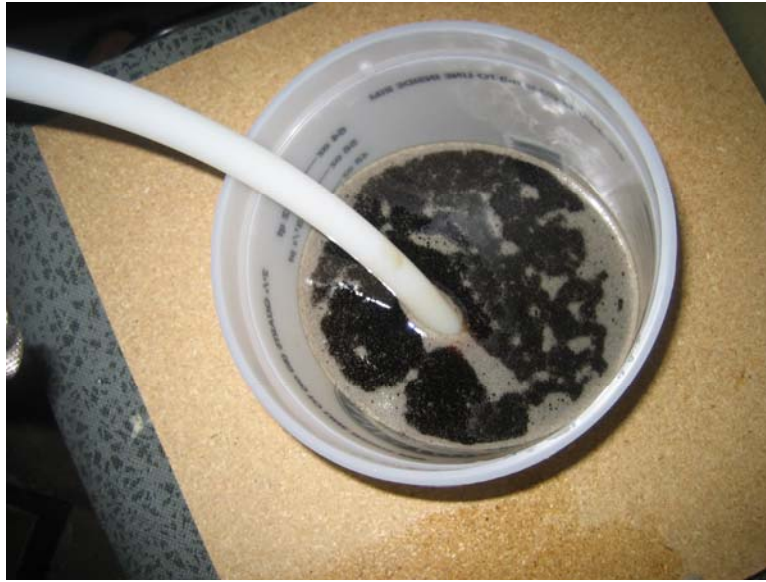
Figure 13. Resin at Inlet with Bubbles after Mixing

While the vacuum was still running, the temperature was noted and the appropriate amounts of resin and hardeners were mixed to ensure a 60-minute cure time. Once mixed, the resin was transferred to the inlet of the vacuum bag and the inlet tube was clamped to prevent the resin from flowing through the sample. As a result of mixing and transferring the resin to a new bucket, small bubbles are formed throughout the resin, Figure 13. Enough time, about ten to fifteen minutes, was allowed for these bubbles to

dissipate before running the resin through the sample. Again, these small bubbles, if allowed to run through the sample, would have gotten caught and ruined the sample.

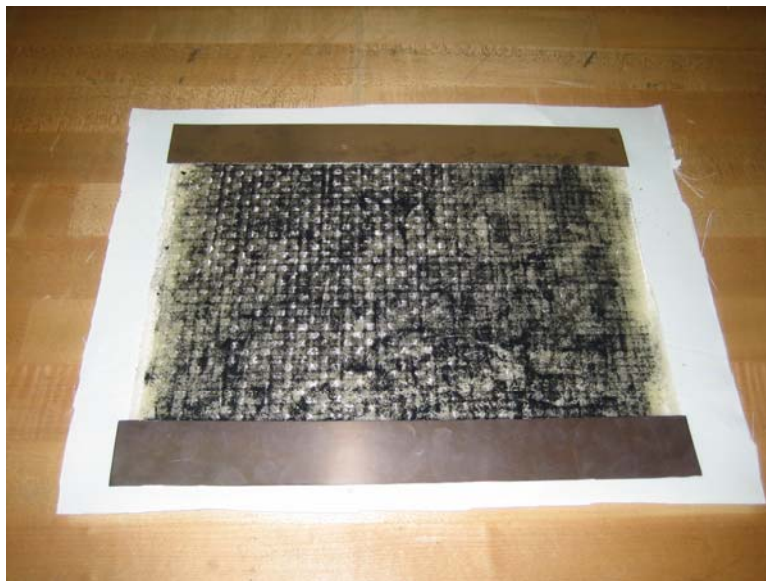
Figure 16. Bottom Layer of Double-Cure Sample Covered With CNTs

Since the bottom layer of the two-step cured sample was the only thing made the first time through, the initial crack and top layer were then manufactured. To do this, the first start step was to take the newly-made bottom layer, and sand the top surface with 100 grit sand paper in order to roughen the surface. Next, the sanded surface was cleaned with acetone, in order to make sure that all sanded particles are removed. The acetone was allowed to fully dry before continuing the VARTM process. When working with CNTs, they were dispersed over the top of the entire sanded composite plate using acetone, and again ensuring enough time was allowed for the acetone to dry, as shown in Figure 16.

For sample sets two and three, thin pieces of stainless steel plates were fastened to the top and bottom of the sample, as shown above in Figure 16. The stainless steel was needed to allow for a place to secure conductive test equipment to the sample and not interfere with any other testing. For all other samples, this step was skipped.

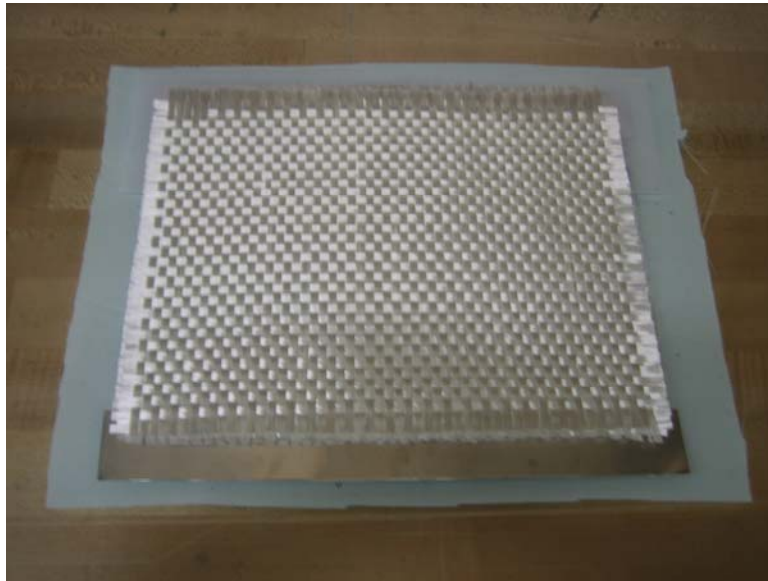
Figure 18. Remaining Fiber Material Stacked on Top of Bottom Plate

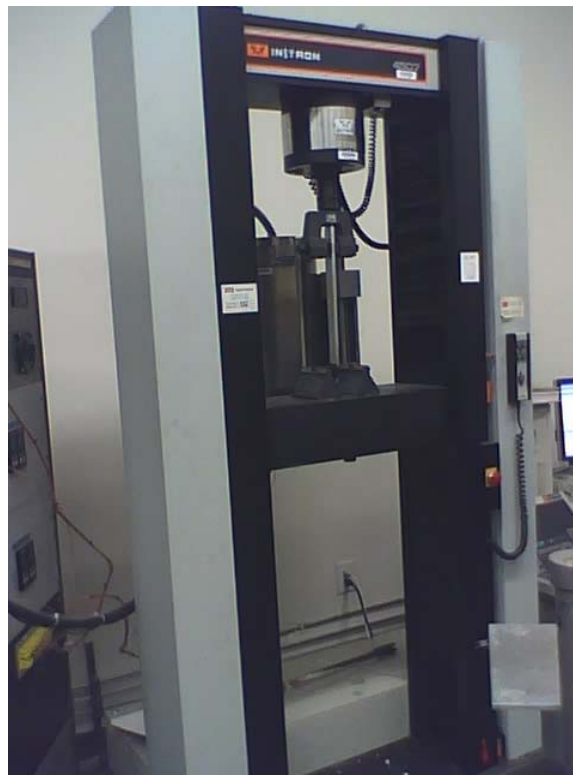
Figure 19. INSTRON Mode II Test Setup

All tests were conducted using an Instron Tension/Compression Machine (Model Number: 4507/4500), shown in Figure 19. All testing phases were conducted using a 10 kN load cell. Collection of data generated by the Instron Machine was done by a Series IX computer software which was also used to control the Instron to achieve desired test requirements. Additionally, for Phase III, IV and V the coupons were hooked up to a Fluke 8840A Multi-meter as displayed in Figure 20. This device was used to measure the resistance within the coupons throughout the entire test period. Data produced from this machine was collected by hand at 30-second intervals.

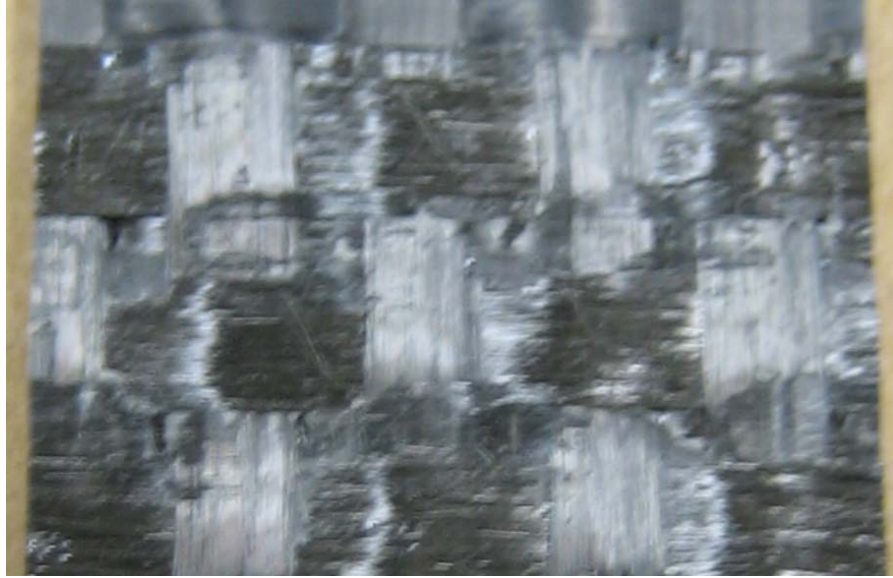
Figure 26. Surface Crack Propagation Path for a Co-Cured Coupon

coupons experienced the same type of failure. In some areas, the joint interface bond was broken through the resin, while in others the resin was pulled away from the fibers, as shown in Figures 26 and 27.

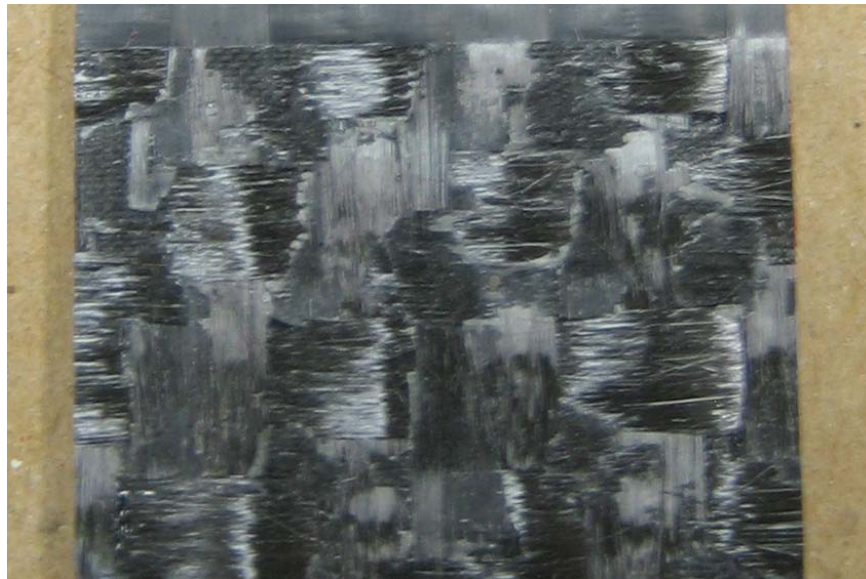
Figure 27. Surface Crack Propagation Path for a Two-Step Cured Coupon

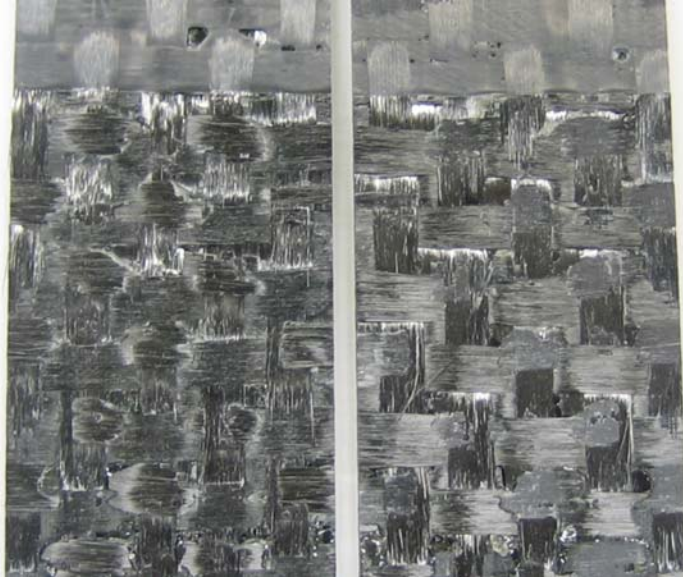
Figure 32. Surface Crack Propagation Path of Carbon Composite Without CNT

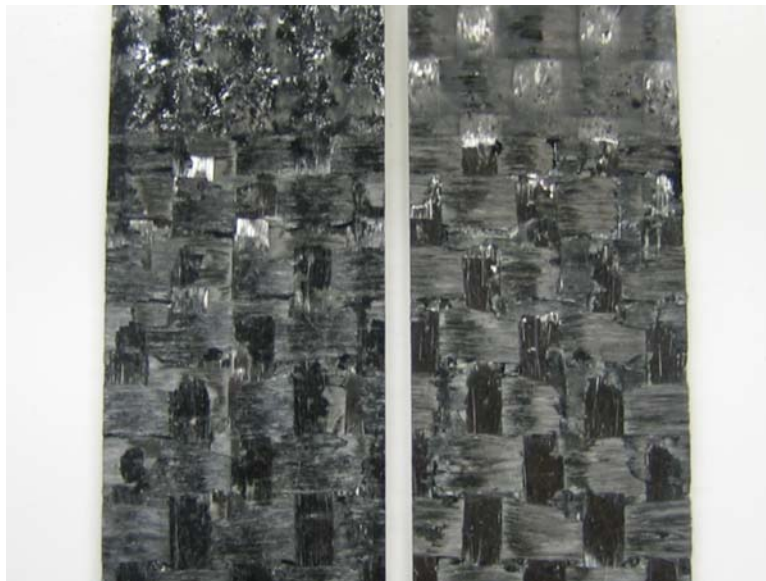
Figure 33. Surface Crack Propagation Path of Carbon Composite With CNT

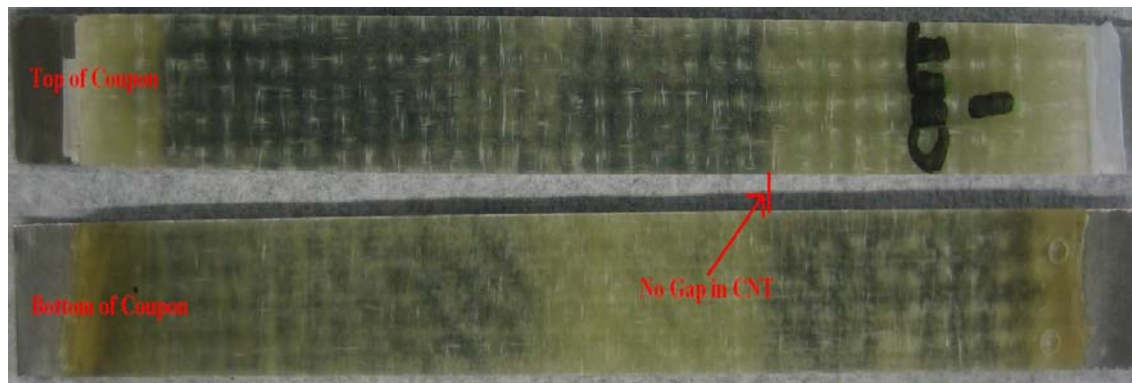
Figure 35. Fiberglass Coupon With Continuous Layer of CNTs

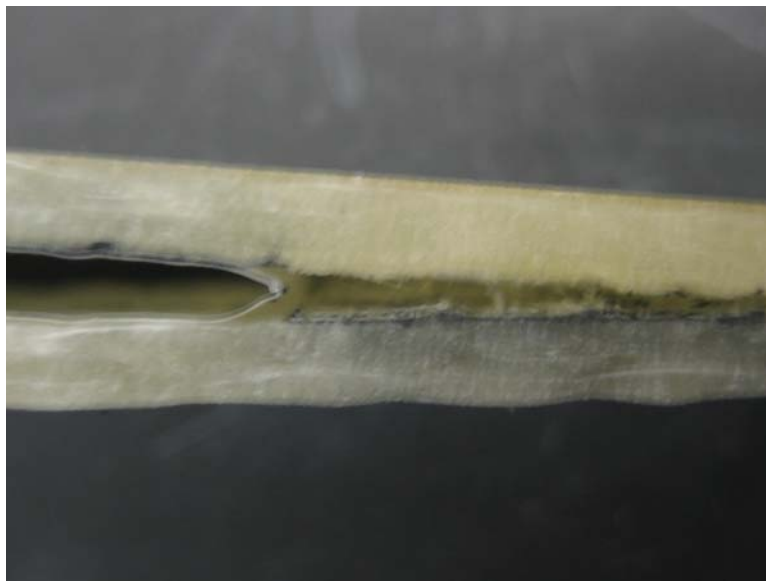
Figure 42. Fiberglass Composites With CNT Path of Crack Propagation Picture

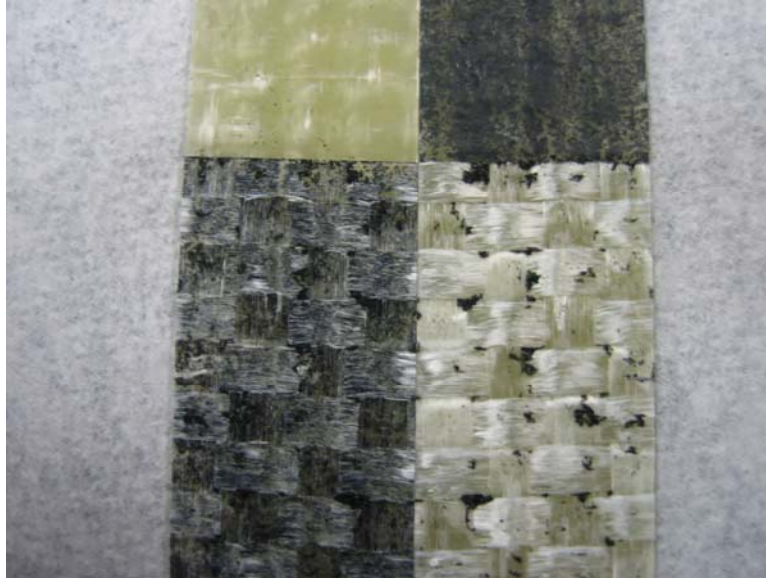
Figure 43. Surface Crack Propagation Path of Fiberglass Composite With CNT

bond was broken through the resin by the crack propagation resulting in the resin being pulled away from the fibers. Both surface interfaces are shown below in Figures 43 and 44.

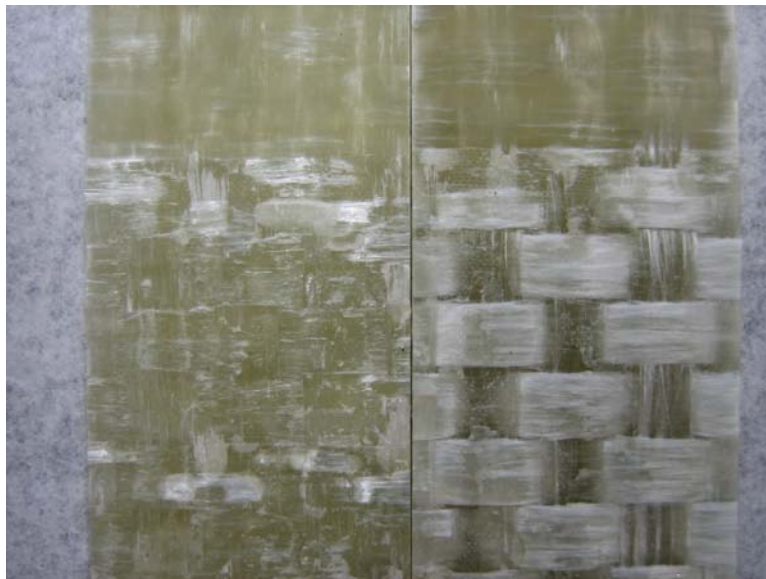
Figure 44. Surface Crack Propagation Path of Fiberglass Composite Without CNT
